S-42 Myrtle Grove Oriole vicinity private Late eighteenth century, c. 1820

Maryland Historical Trust State Historic Sites Inventory Form

Survey No. S-42

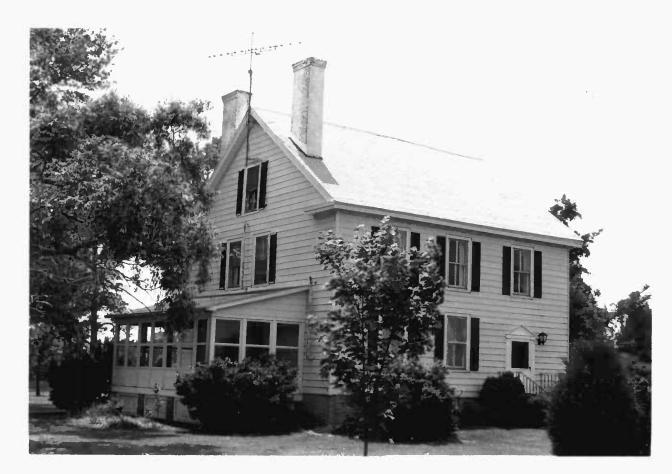
Myrtle Grove S-42
Oriole vicinity, Somerset Co., Md.
North Elevation
5/86, Paul Touart, Photographer
Neg./Md. Historical Trust

The north (back) side of the main house is an uneven wall surface. Three bays with a west side entrance define the main block, while two additional bays are stepped in from the principal wall surface. The rear entrance is trimmed with a modern Colonial surround, and two-over-two sash windows light the first and second floors. In addition, two diamond cross-sectioned grilled openings pierce the foundation wall.

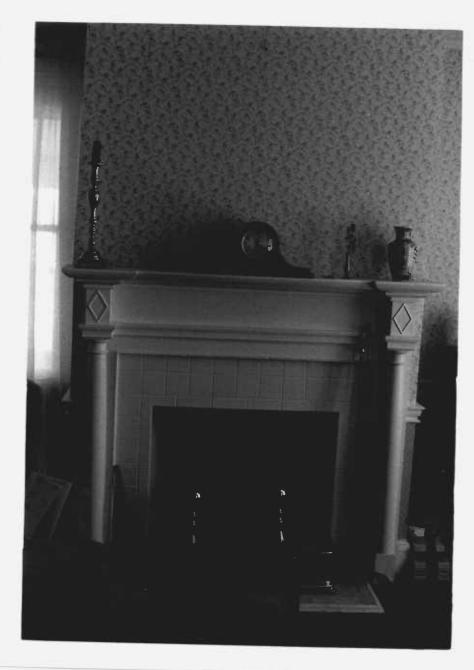
Myrtle Grove S-42
Oriole vicinity, Somerset Co., Md.
Mantel - Parlor
5/86, Paul Touart, Photographer
Neg./Md. Historical Trust

From the hall access is provided to the two principal first floor rooms through slightly raised eight-panel doors, which are framed by thumb molded surrounds. Each doorway has paneled reveals. Both first floor rooms retain early nineteenth-century chair rail, base-boards, and mantels. The mantels in both rooms follow Greek Revival style designs with semi-detached Tuscan columns that support protruding frieze blocks and stepped broken shelves. The frieze blocks in the south room have a diamond design. Joining the two rooms are large ten-panel double doors framed by fluted surrounds with bullseye corner blocks. The niche to the left of the mantel in the north room (dining room) is filled with an eight-panel door closet.

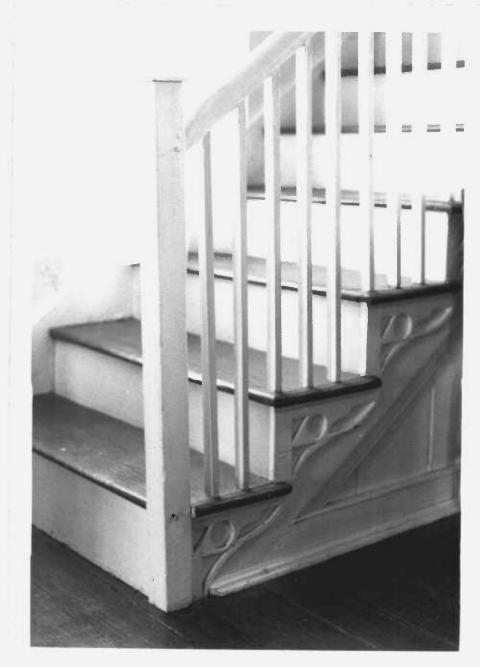
Myrtle Grove S-42 Oriole vicinity, Somerset Co., Md. Stair 5/86, Paul Touart, Photographer Neg./Md. Historical Trust

The side hall contains a Federal style stair that rises in an open flight to the attic in the northwest corner. A square newel post and three rectangular balusters to each tread support an oval profile handrail. The stringer is decorated with an unconventional stepend pattern, and the triangular area below the stringer is finished with vertical beaded boards. The stair rises in three flights to the attic.
